# Site Report: Mostar, Bosnia and Herzegovina

# Plan of activities

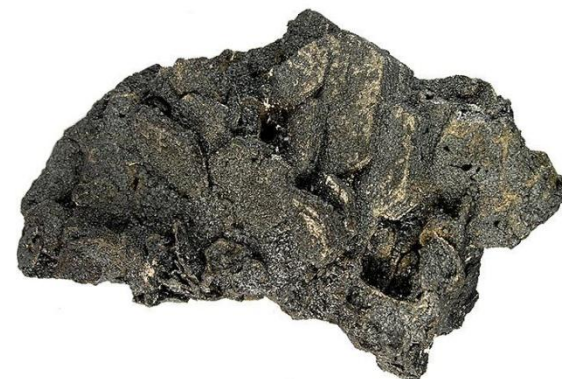
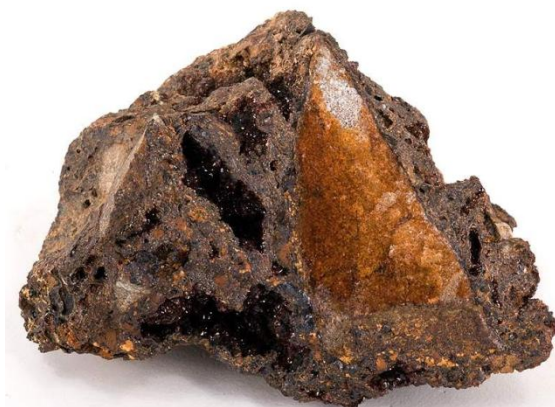
Fig. 3. Processes that lead to secondary sulfate-mineral formation from oxidation of primary Fe-sulfide minerals. Acid-generating steps are underlined. Reactions based on those of Scharer et al. (1994), Bigham (1994), Plumlee (1999), Rose and Cravotta (1998), Bigham and Nordstrom (2000), and Jambor (2003).

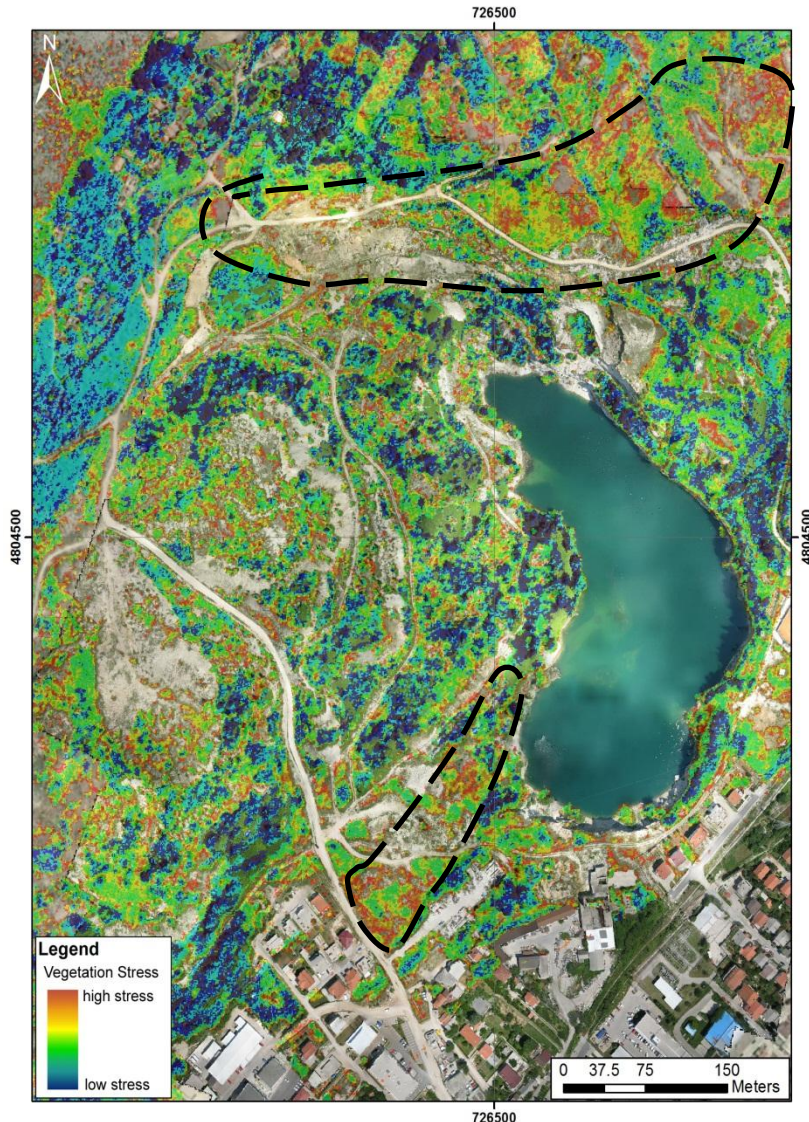
Hyperspectral data

Areas of vegetation stress correspond with the zones of former ore crushing (south) and burning regions (north) – note spread (downwind) of CO<sub>2</sub> and H<sub>2</sub>S and vegetation stress

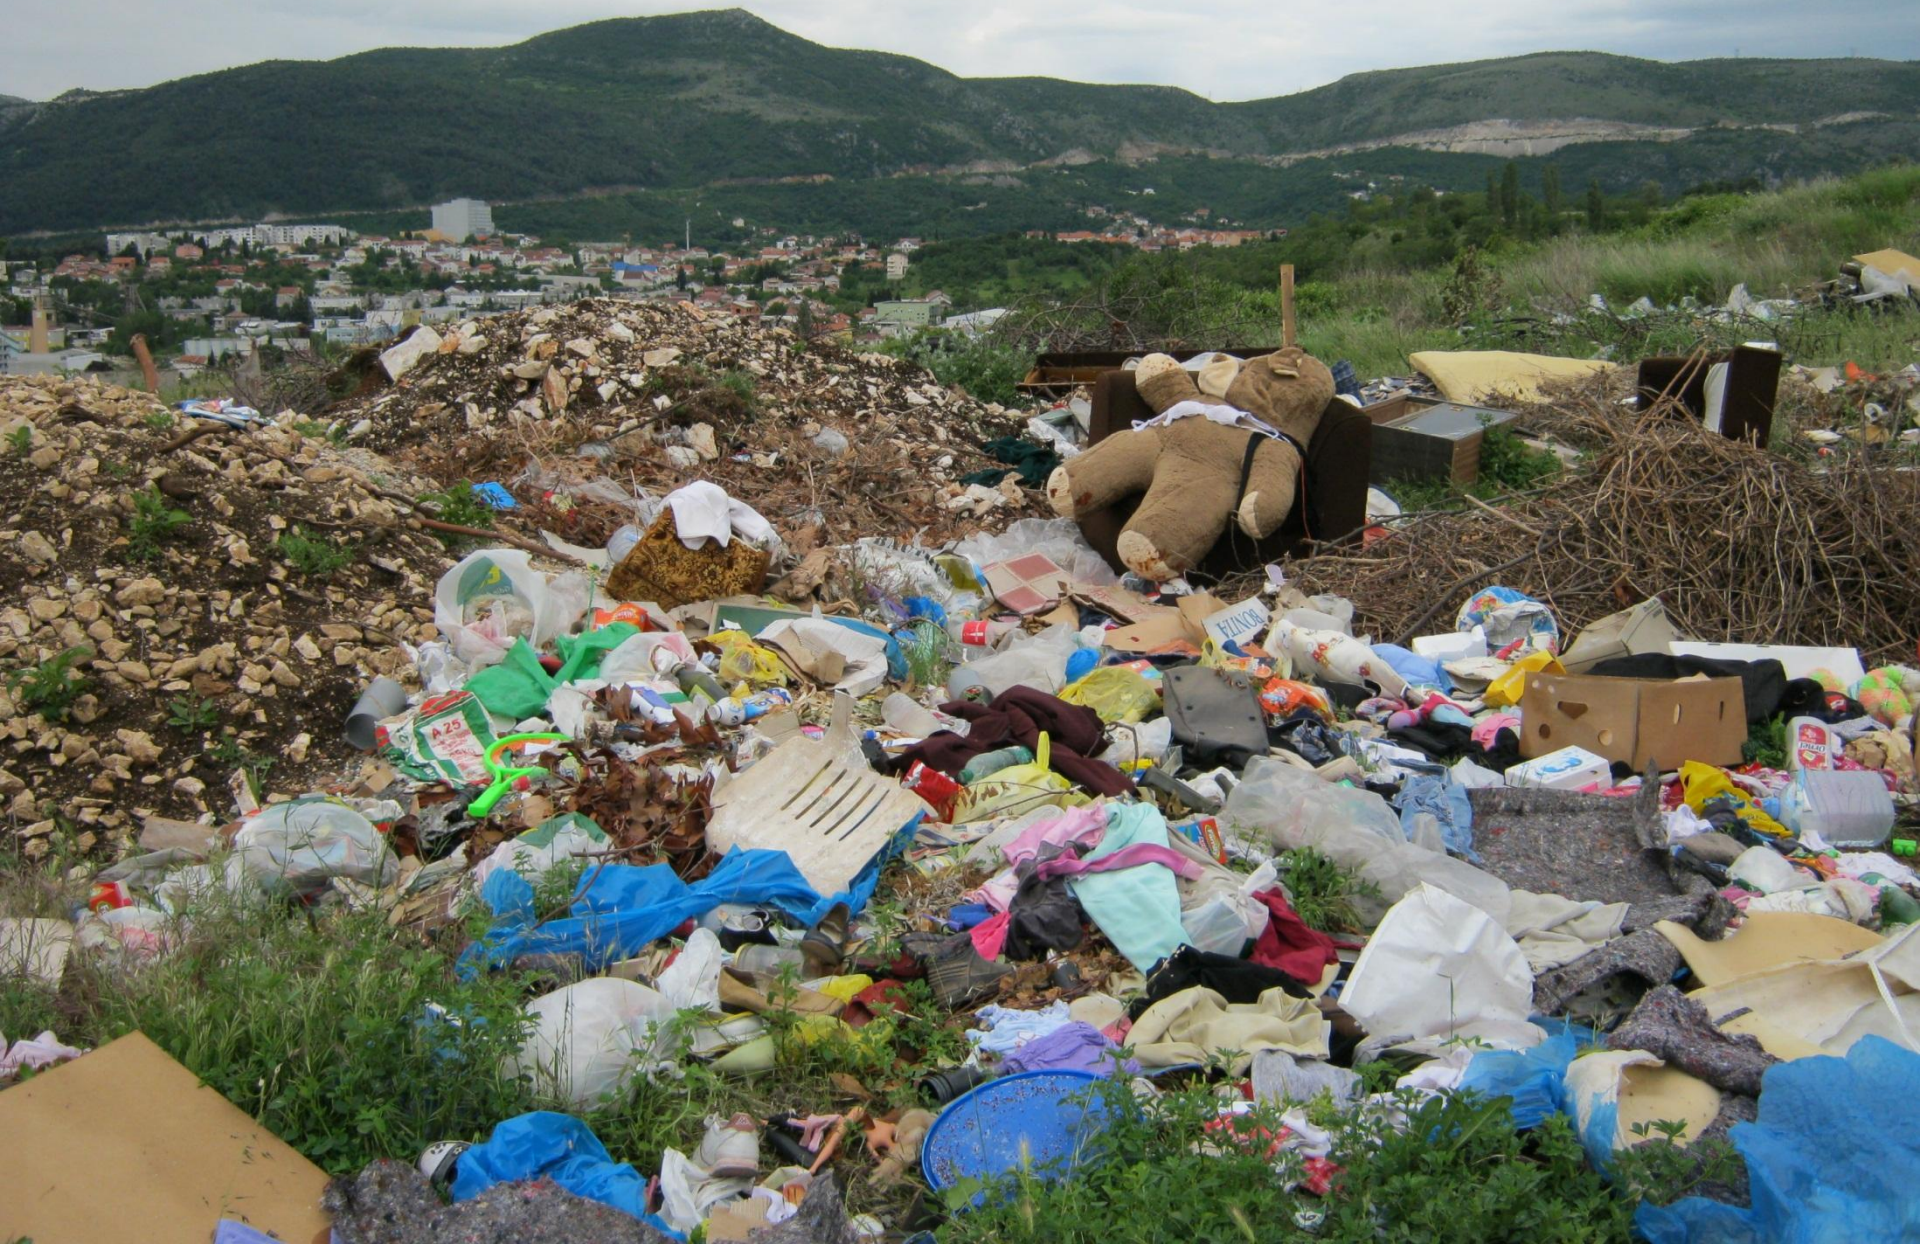
Bigger problem are the illegal dumps of household and industrial waste...

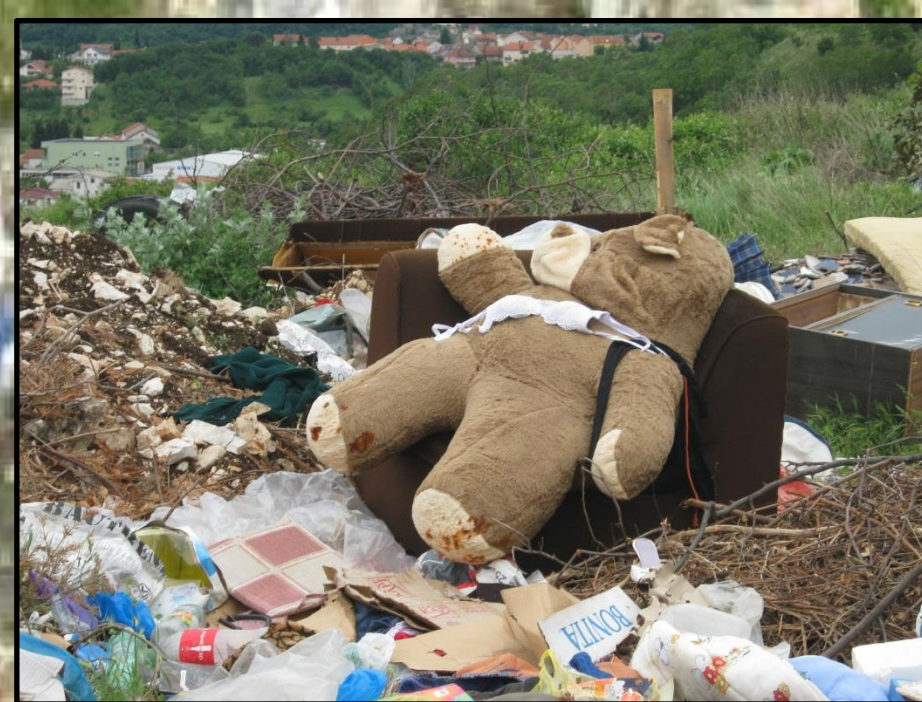
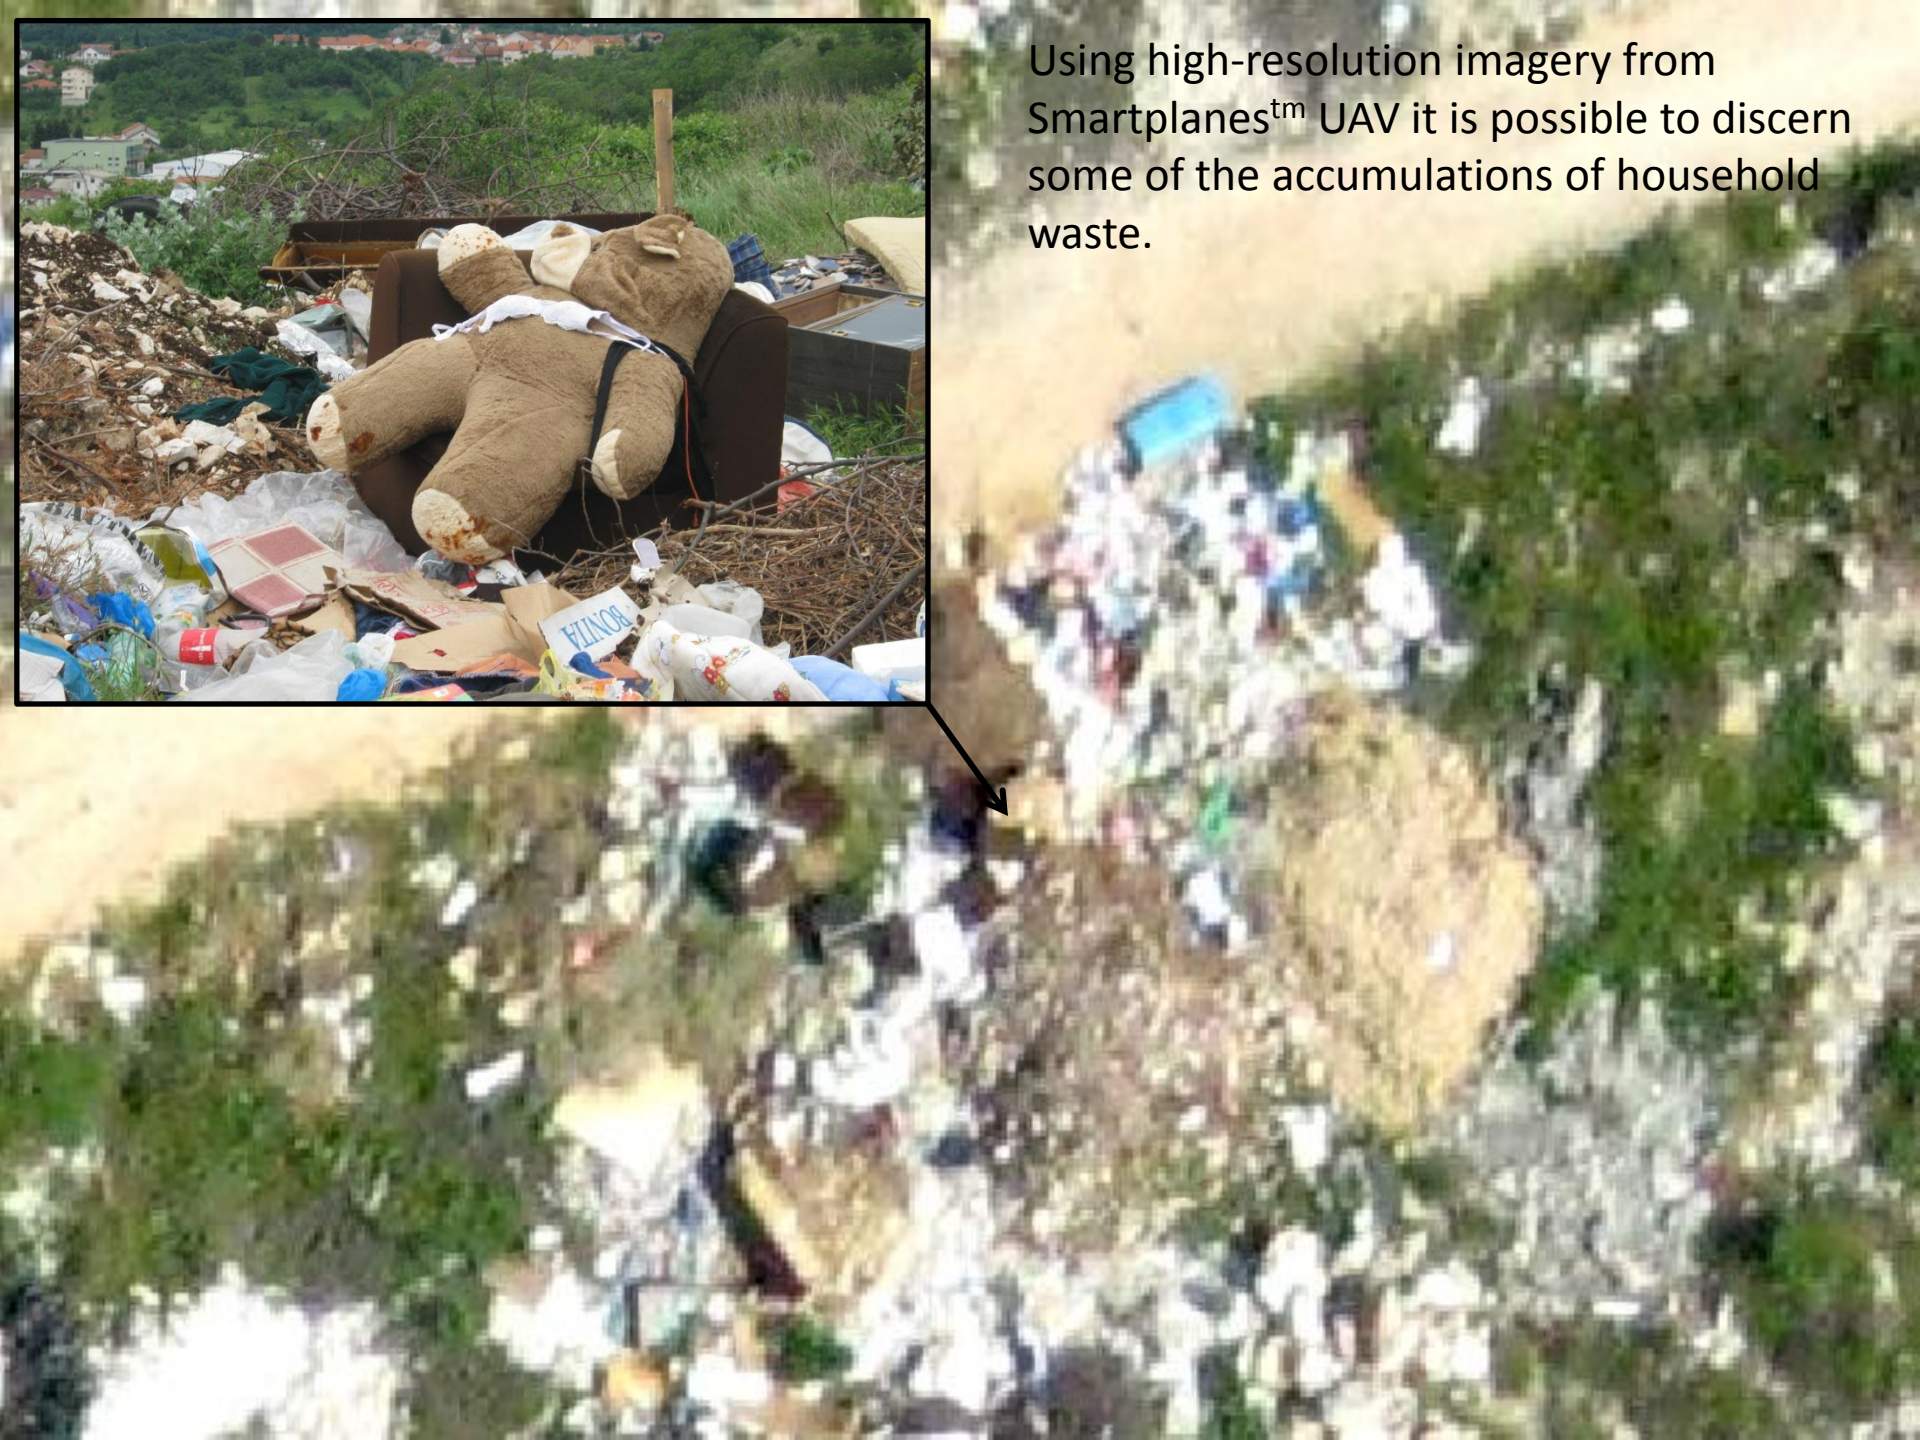
Using high-resolution imagery from Smartplanes<sup>tm</sup> UAV it is possible to discern some of the accumulations of household waste.

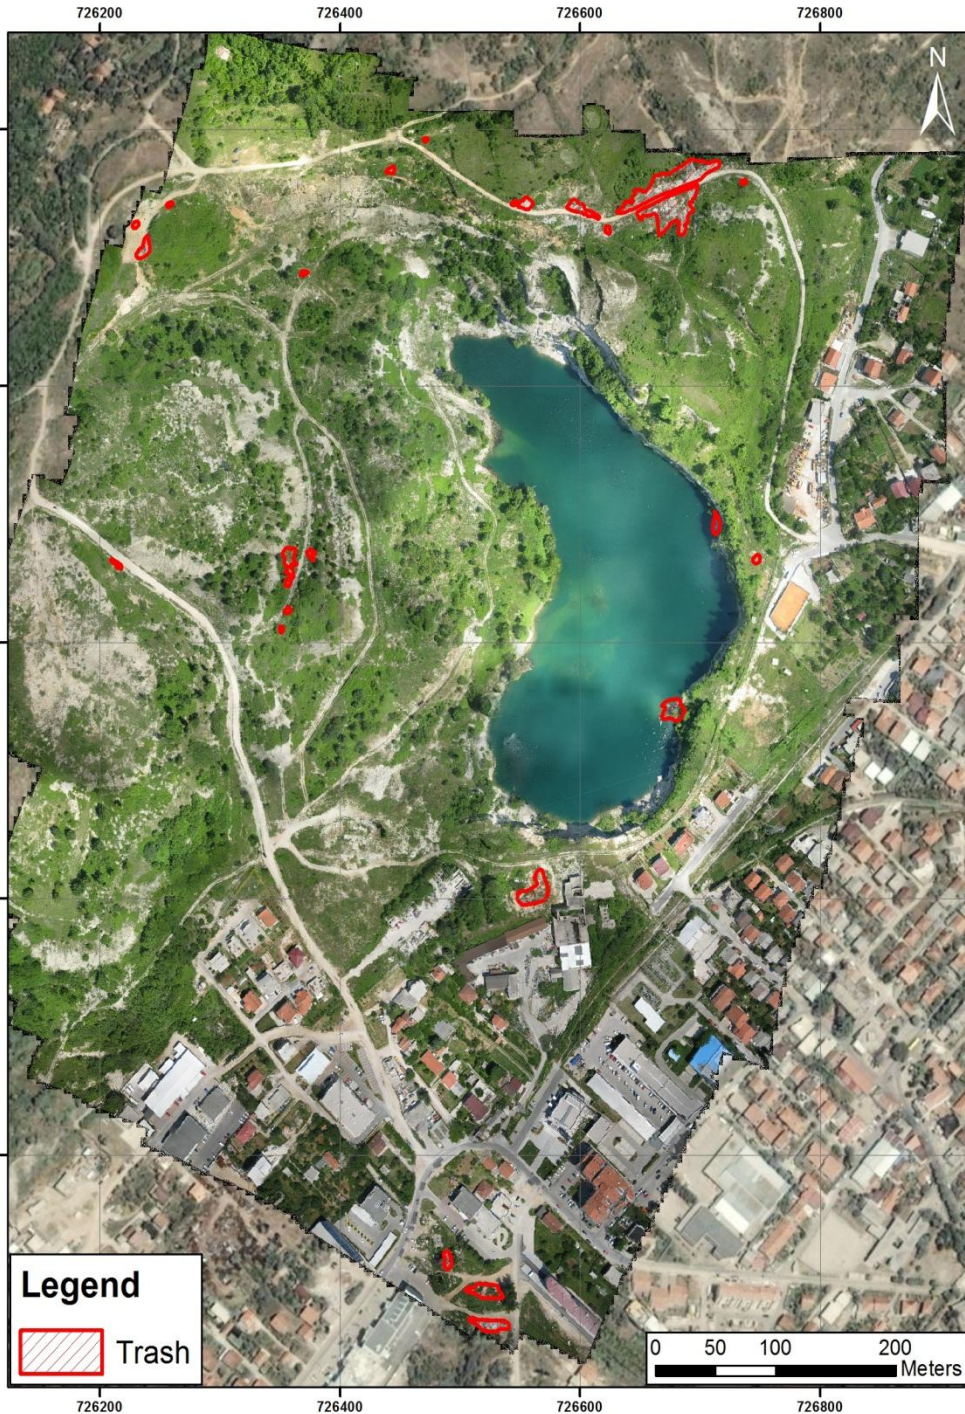
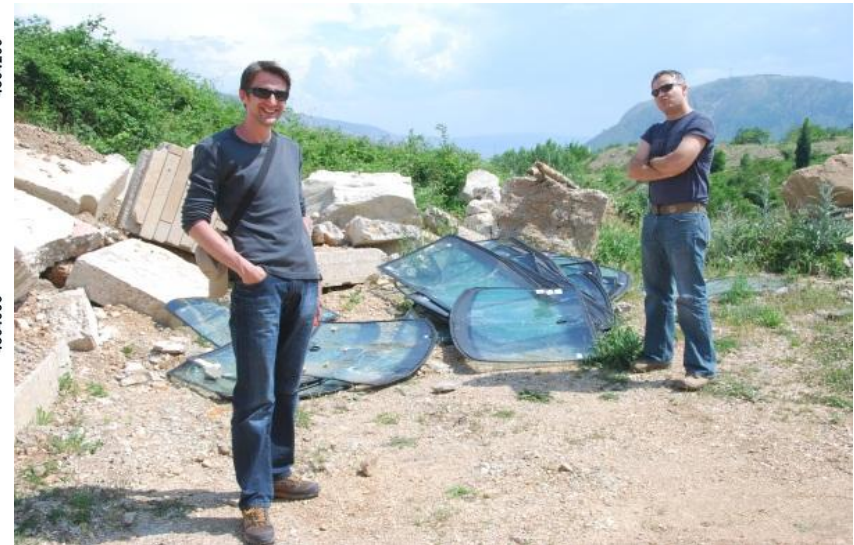
Concentrations of household waste noted on the high-resolution imagery as well as hyperspectral data.

These accumulations formed from 2010 to present day and are growing considering no access control to the mine.

Problem that needs to be addressed before area returns to state before 2007

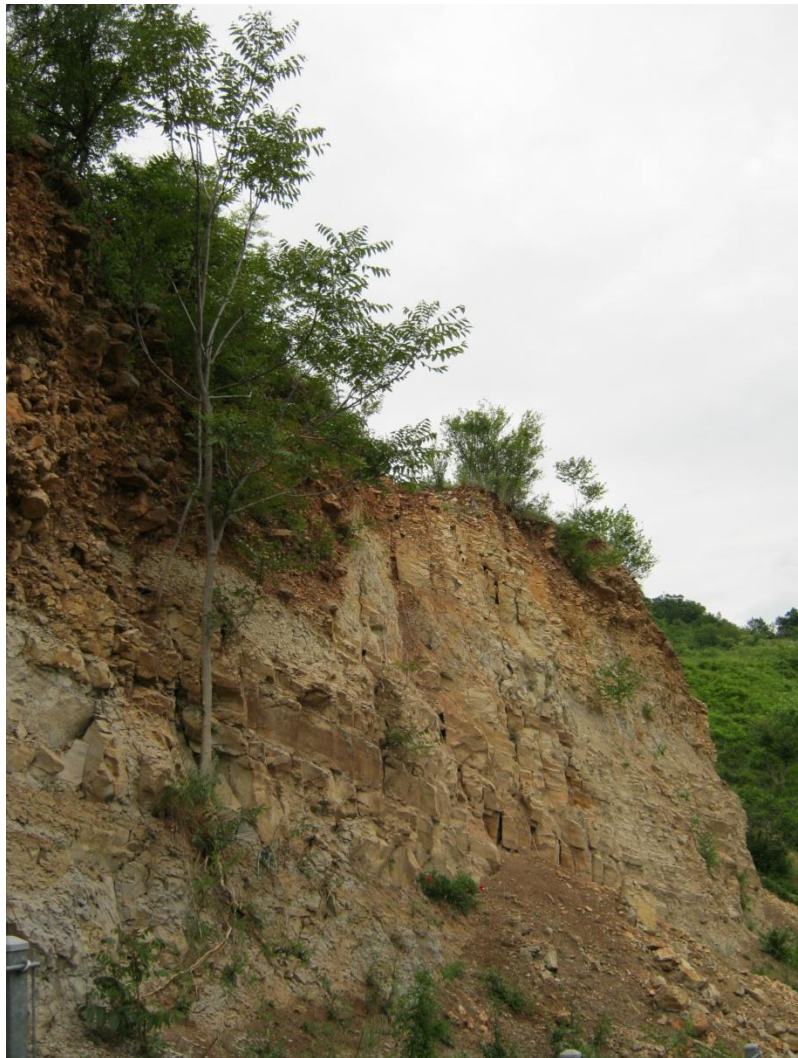
Some of the observed slopes are in an extremely unstable conditions and are in imminent possibility of collapse, possibly along the planes further weakened by weathering and burning.

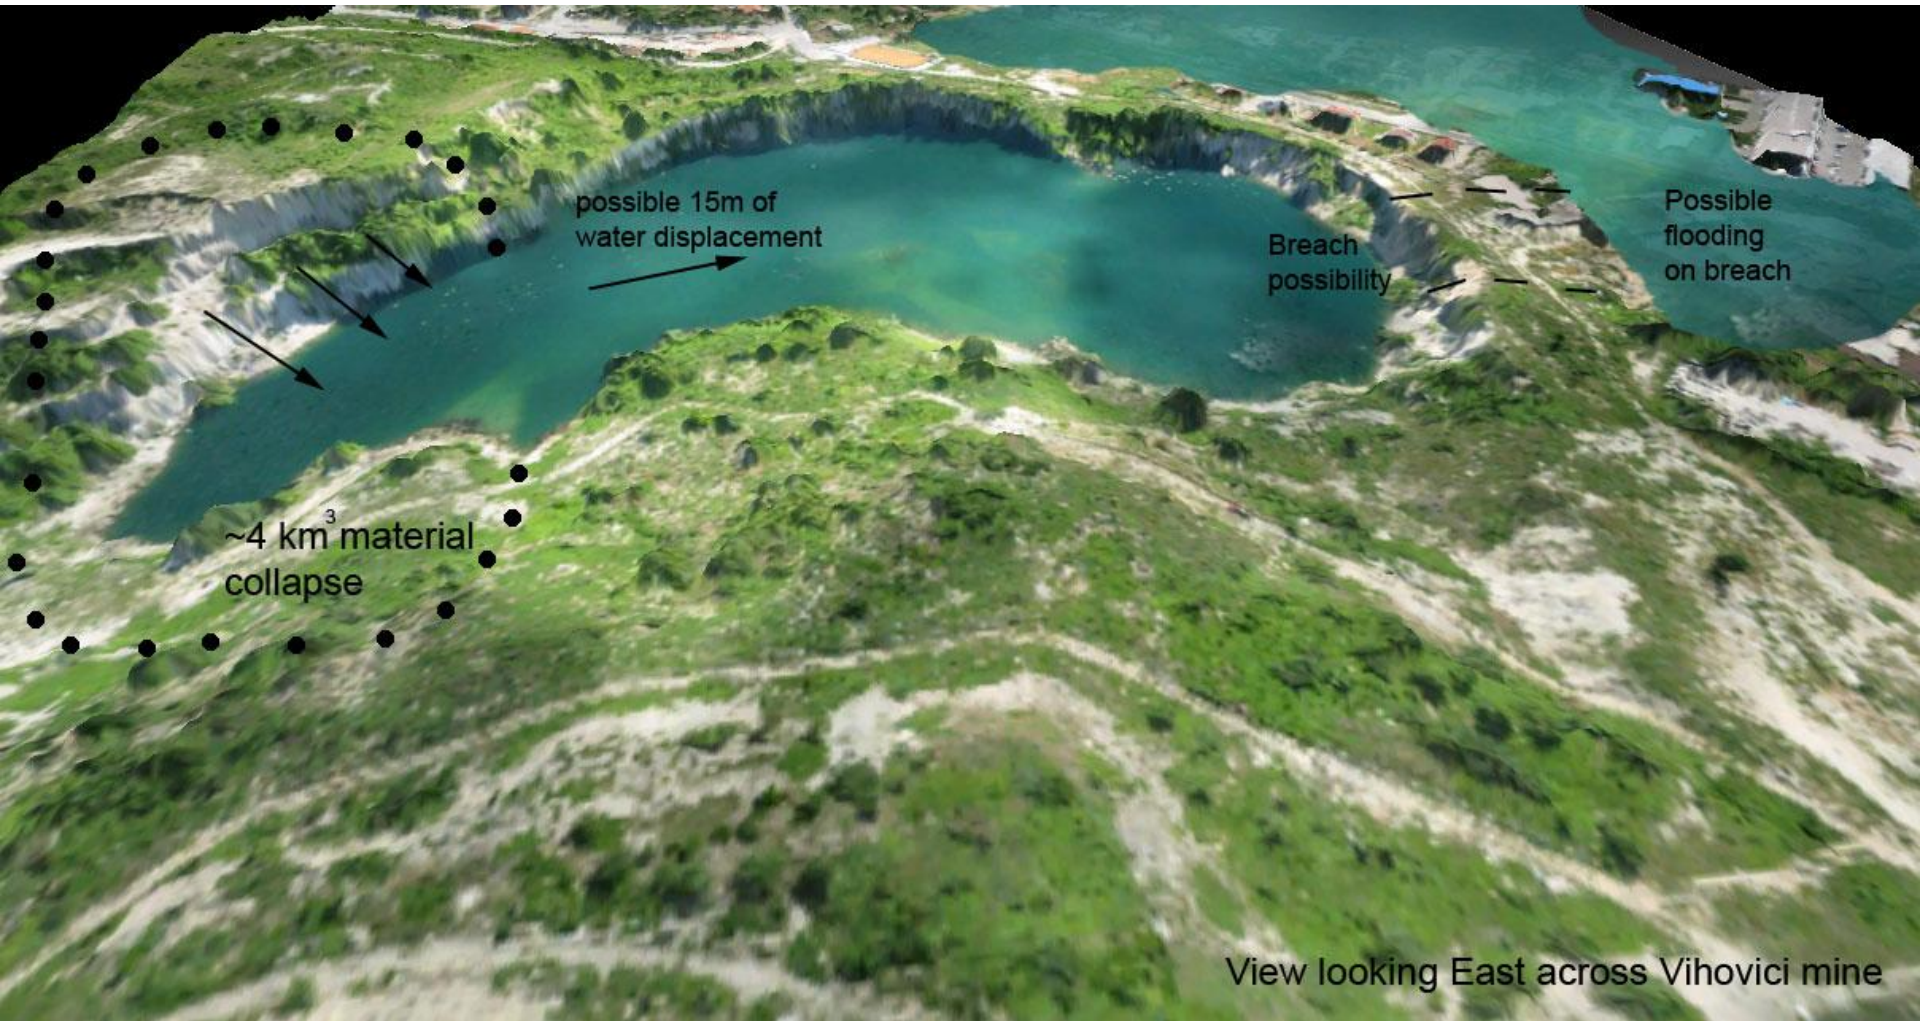
# Simulated scenario of pit breach

(based on collapse of the northern wall into the lake)

Large volume of water and material may surge out of the ruptured pit

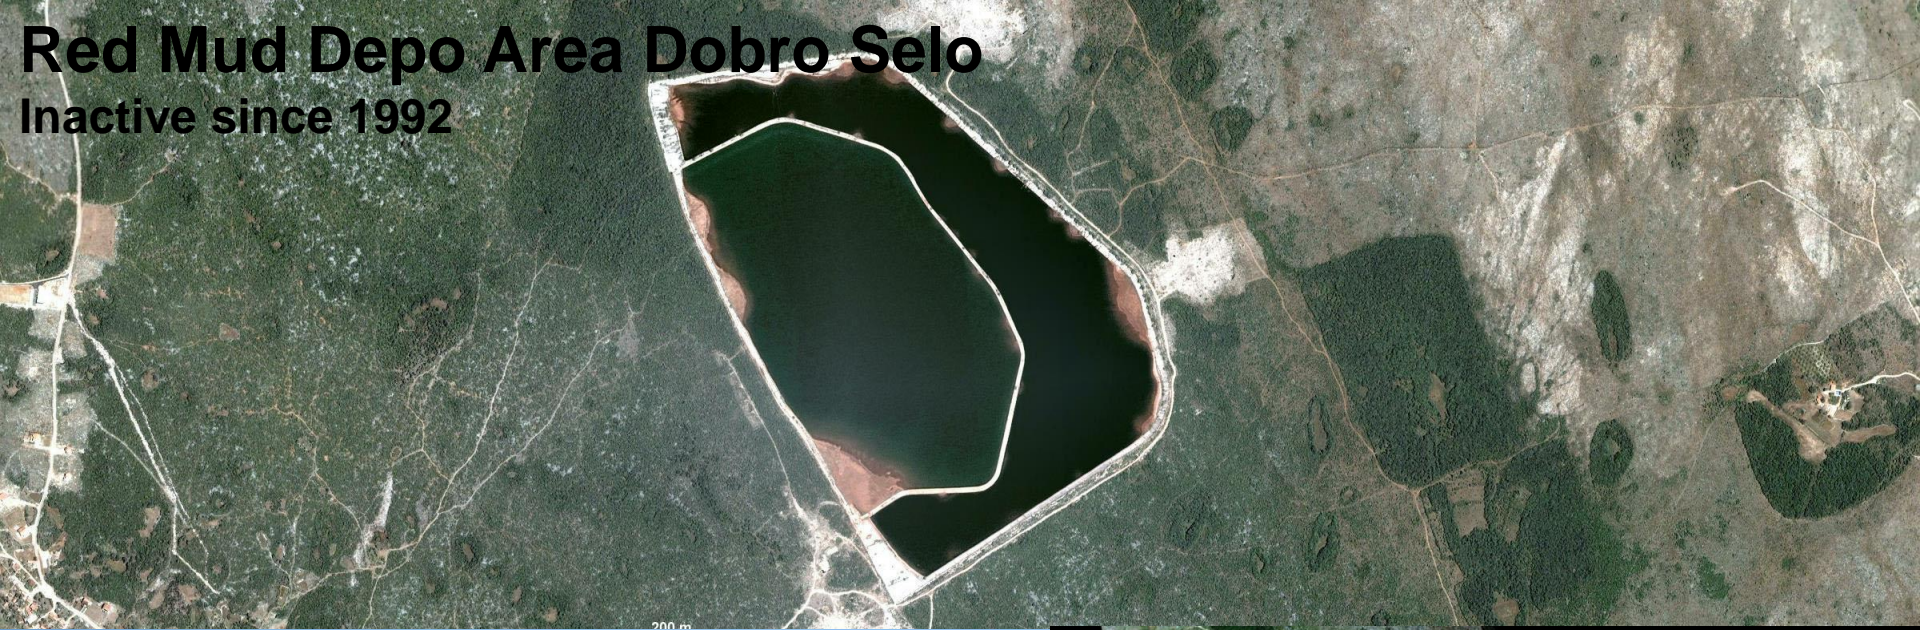
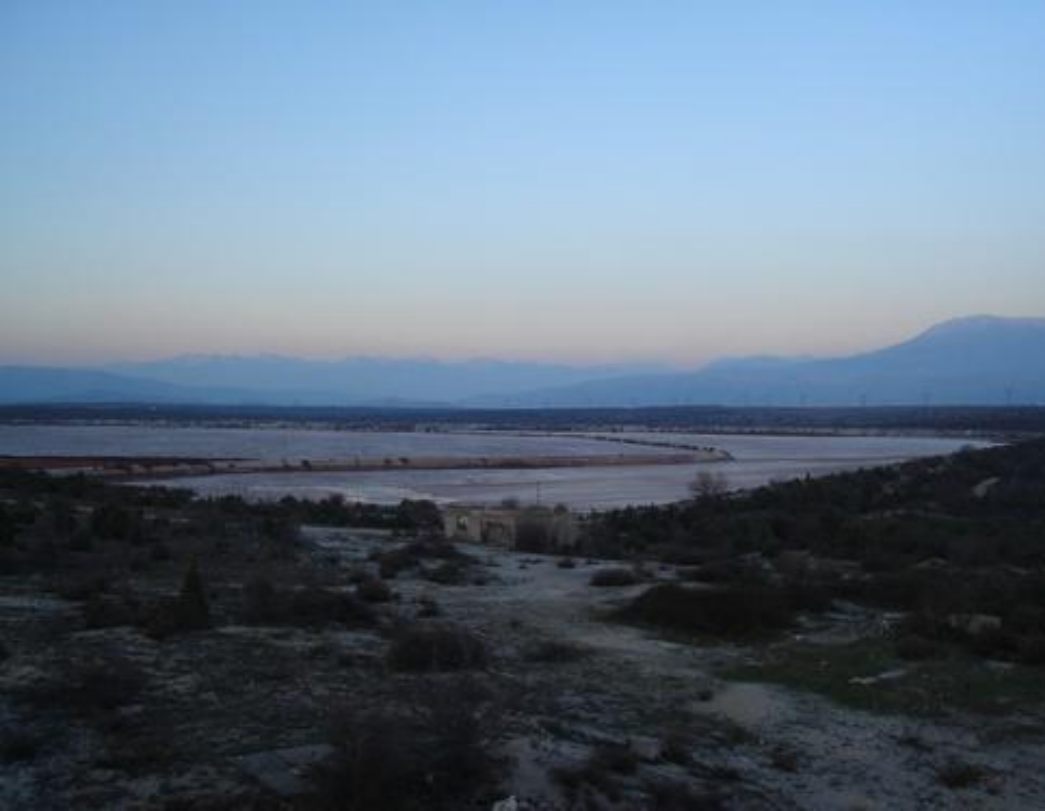
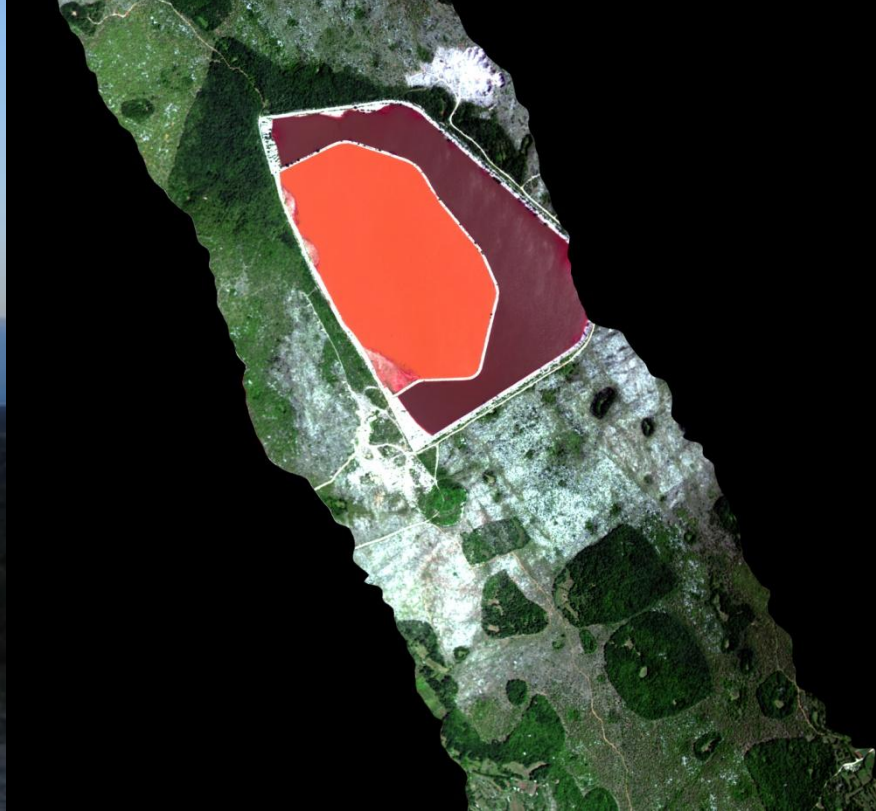
# Red Mud Depo Area Dobro Selo

Inactive since 1992

Hyperspectral data analyzed using red-mud reflectance index (developed after Hungarian spill).

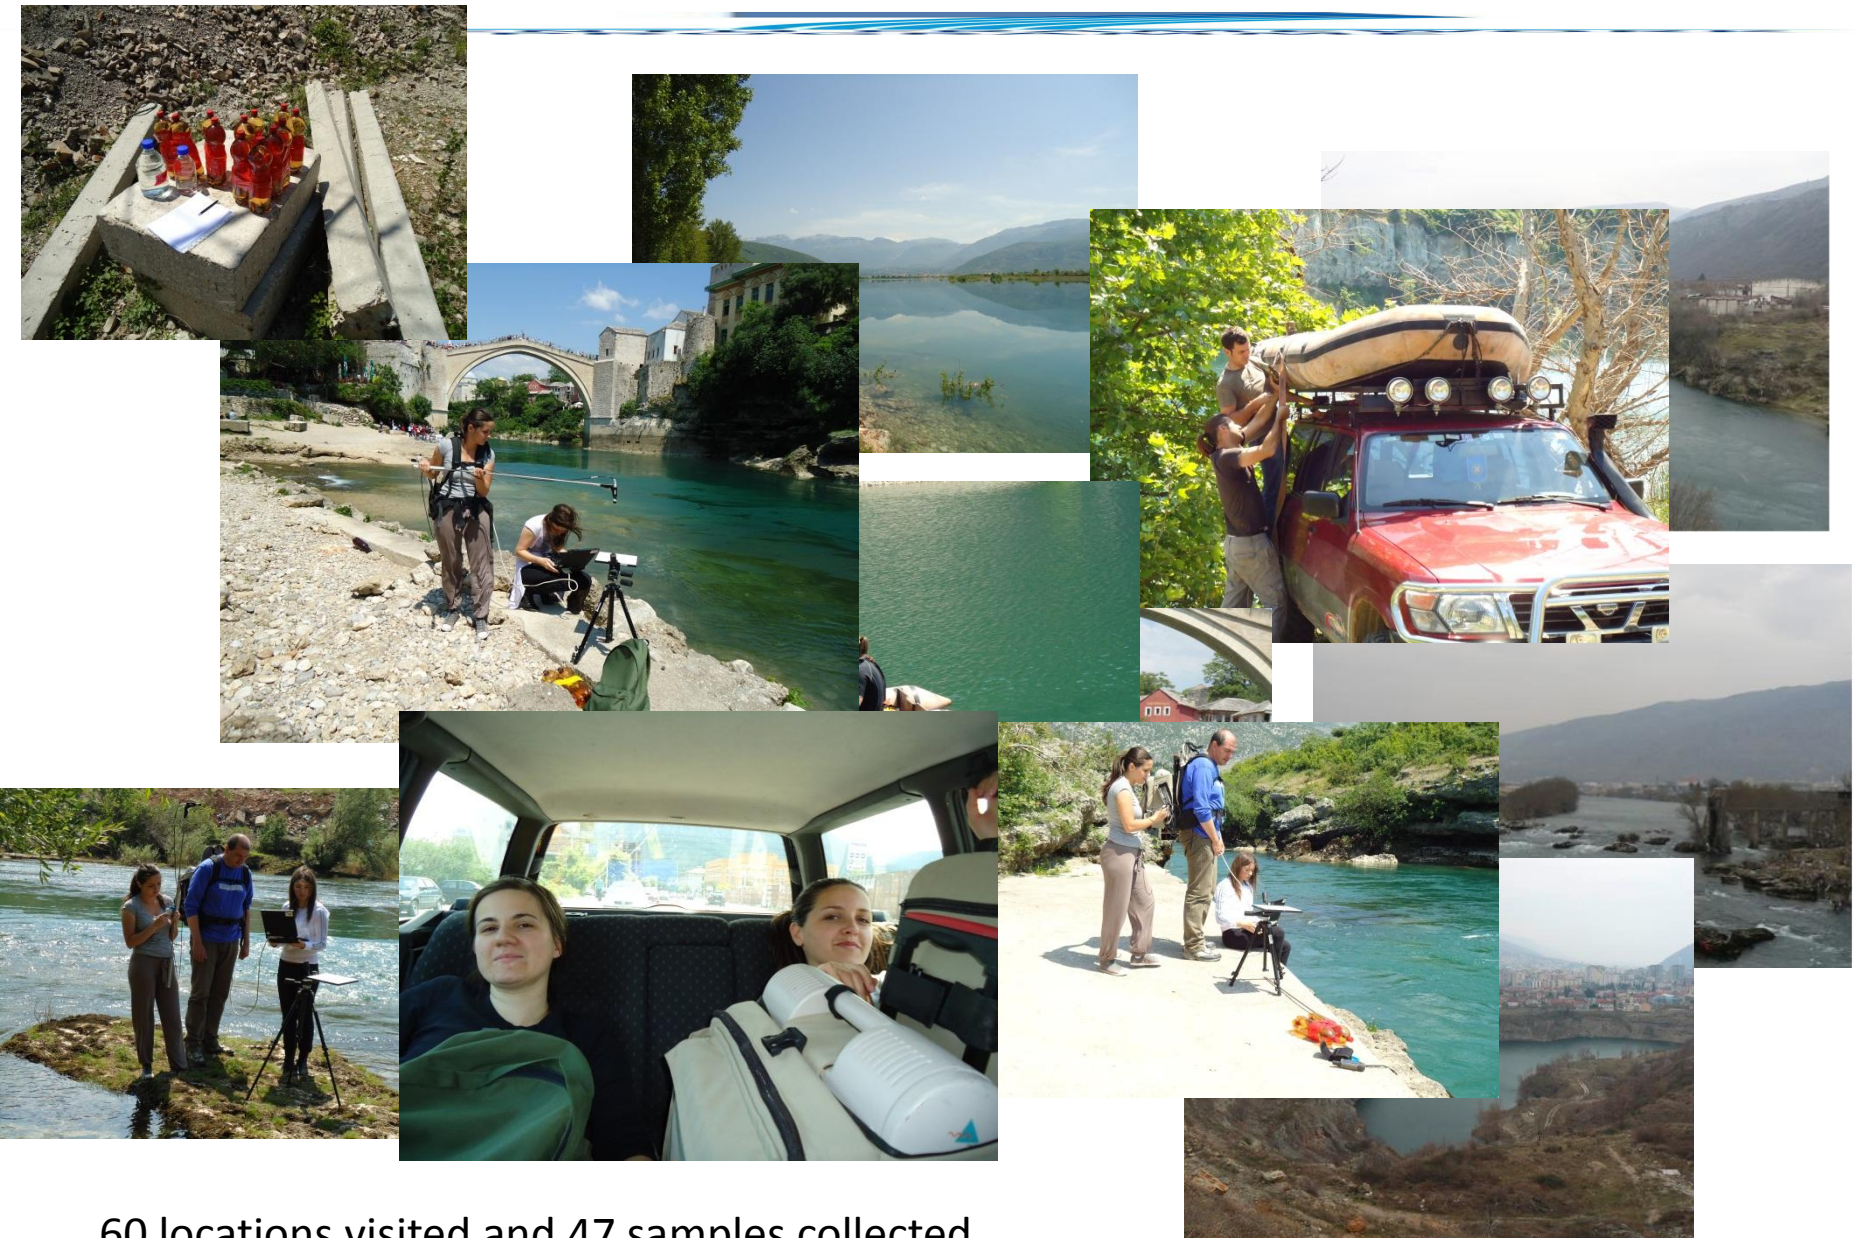
# Sampling

60 locations visited and 47 samples collected

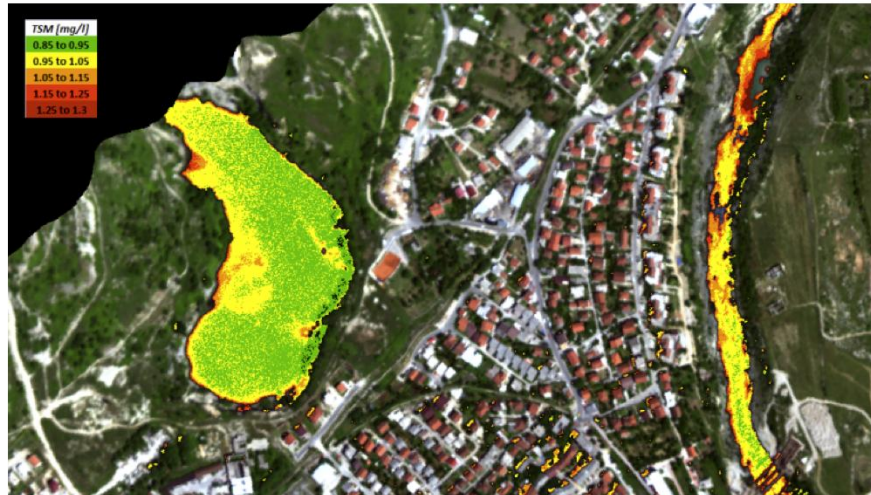
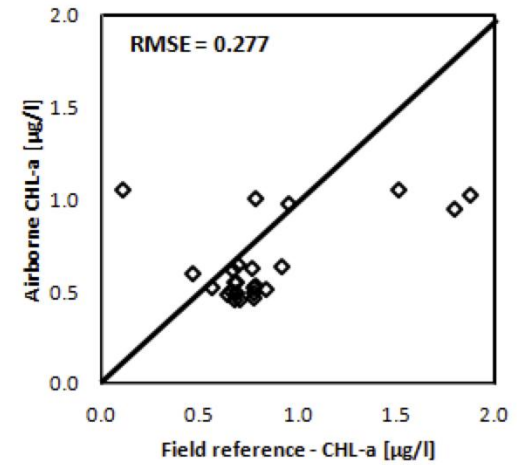
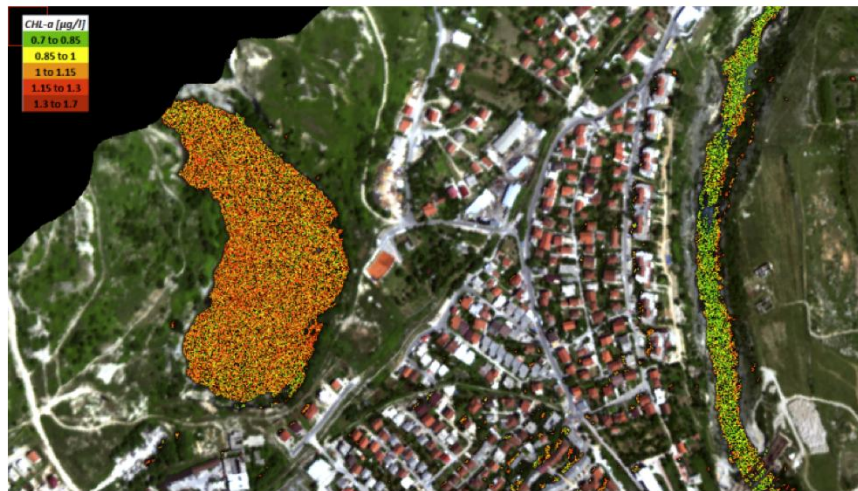
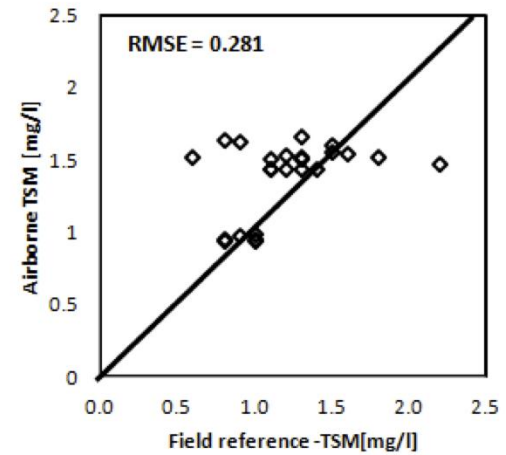
Figure 1 - Results of the Mostar Water quality map and ground validation: TSM and Chl-a.

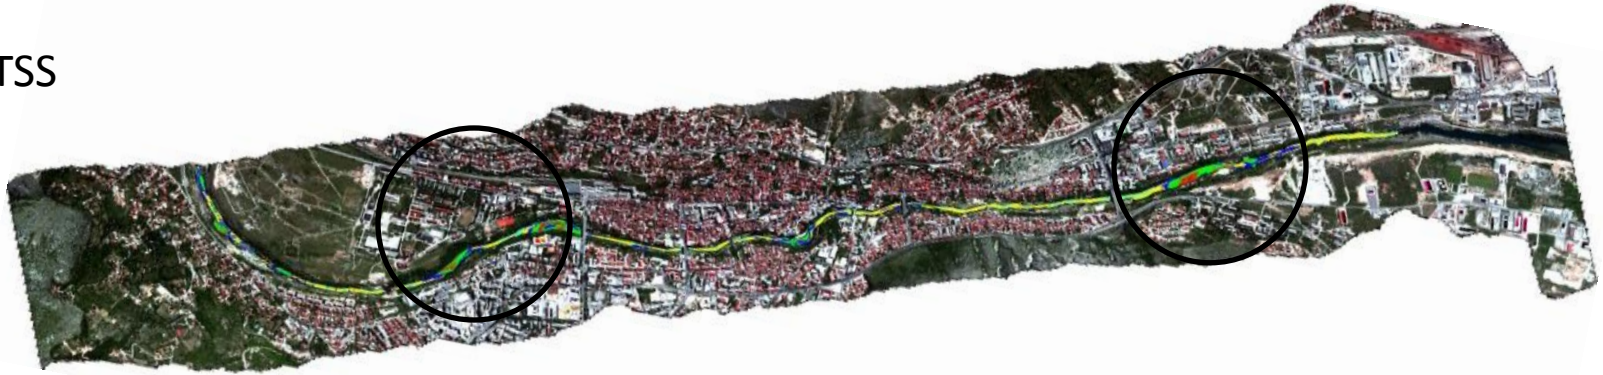
TSS

Biggest polluter is possibly  
(relatively) the City of Mostar

Last week collectors and  
separators were put in use by the  
City.

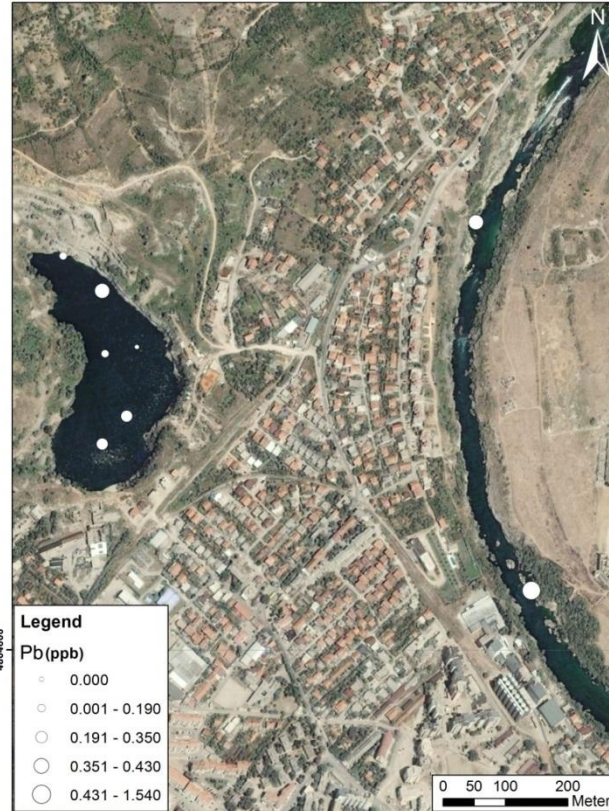
Difficult to make firm impact calls based on too few samples, but Cd, Pb and Fe are all present in the lake, in greater concentrations than in Neretva.

Also, values for Cd, Pb and Fe are all elevated on the measurement point below the Neretva Tunnel

- Neretva river primarily affected by the urban environment and discharge from the urban area
- Difficult to discern all elements in fast-moving river
- Faint evidence of increased organic matter and heavy metals in the small number of samples taken – more detailed study of sediment recommended (20 years of accumulation).
